RAILECT

“Development of an ultrasonic technique, sensors and systems for the volumetric examination of aluminothermic welds”

IoRW Seminar – 1st December 2010

TWI Ltd

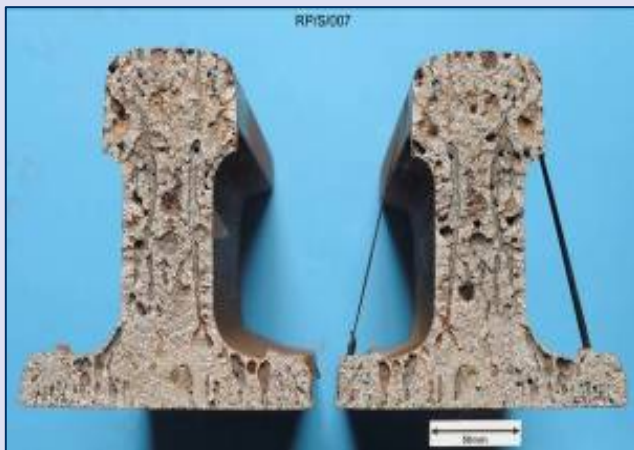
Porosity

- These defects can cause welds to fail in months rather than years resulting in risk to safe operation and track closures for repairs

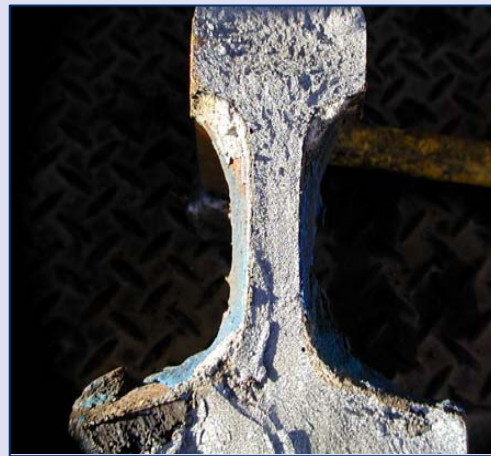
Lack of fusion

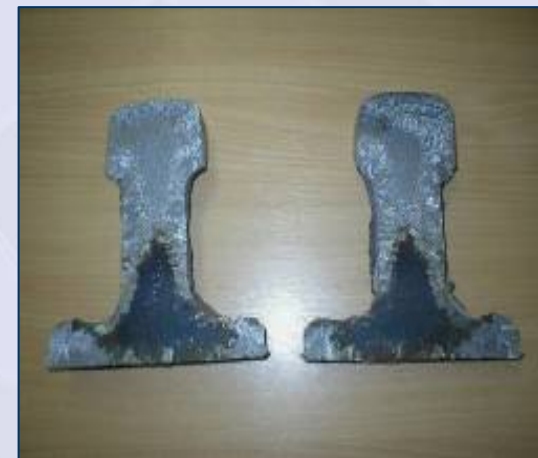
Shrinkage

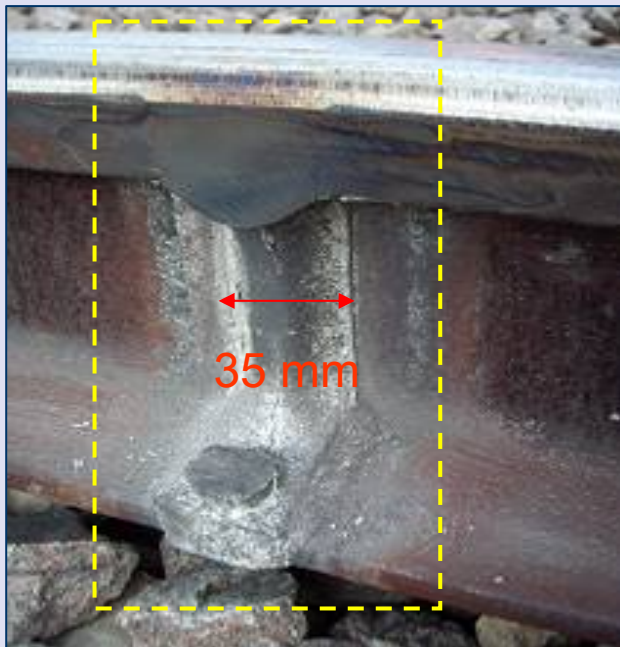
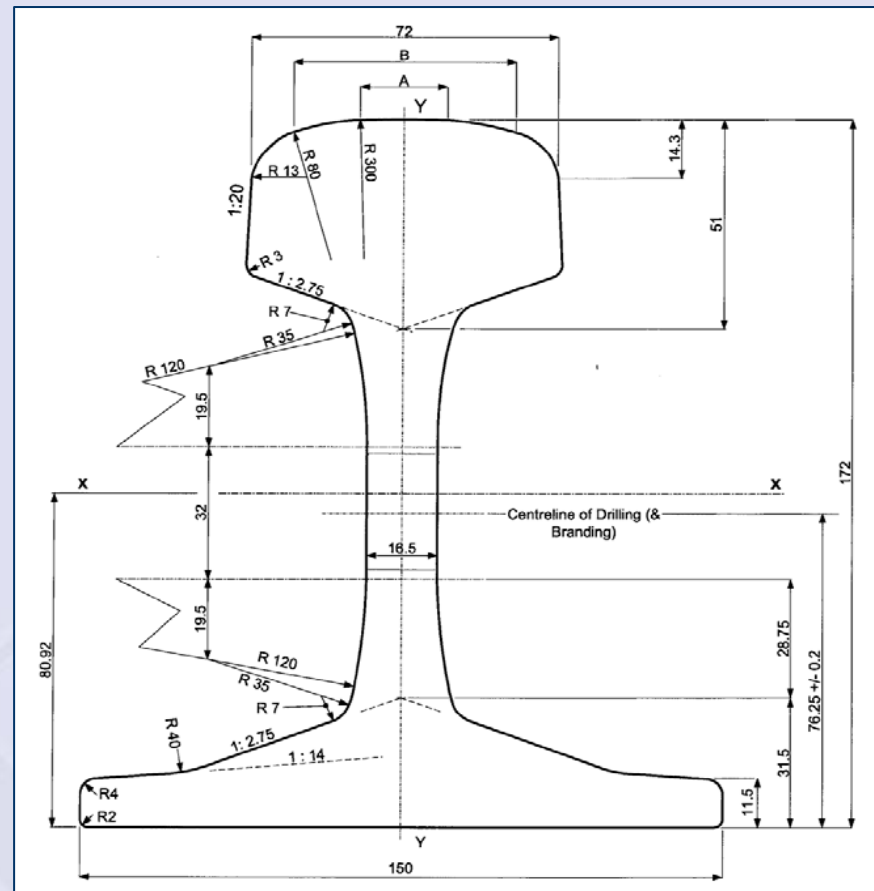
- Inspection of AT welds
 - CEN 60E1 or CEN 60E2 rail profiles
 - Finished cast width of 35 mm

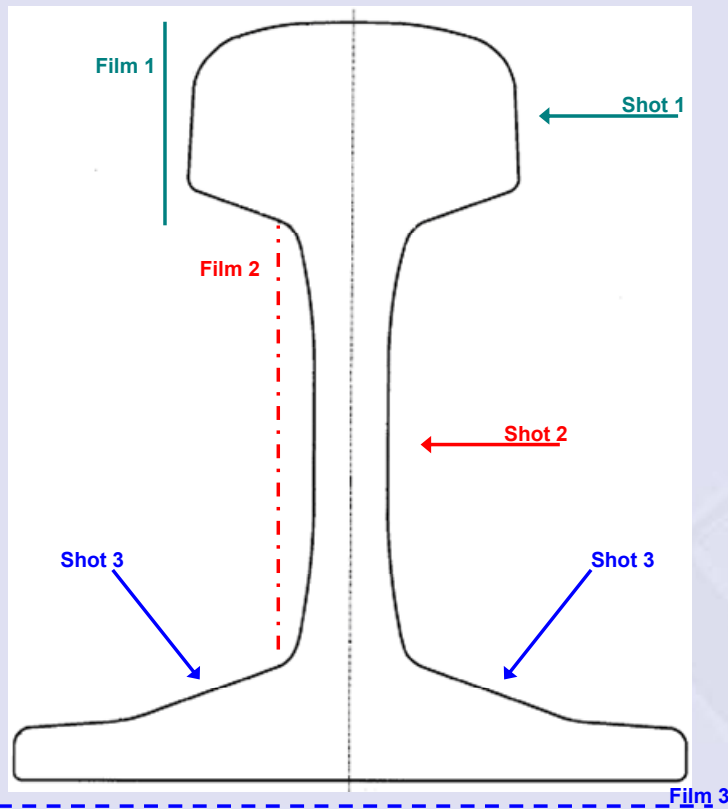
- Procedure for rail CEN60 E1
 - Associated document BS EN 1435 : 1997

In total, 3 shots:

Shot 1: Head

Shot 2: Web

Shot 3: Foot

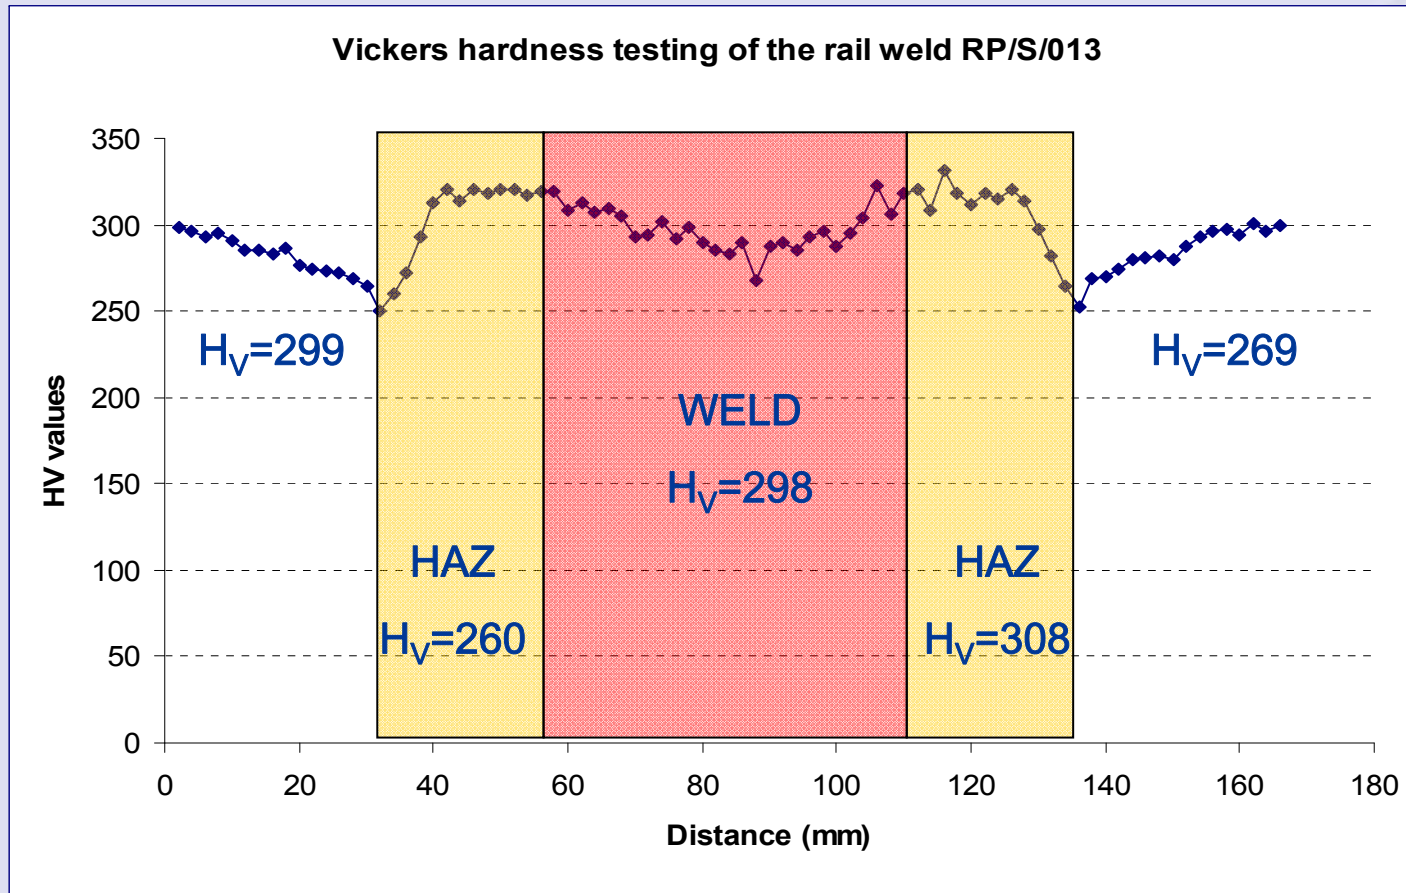
Hardness Testing

- Test results (RP/S/013)

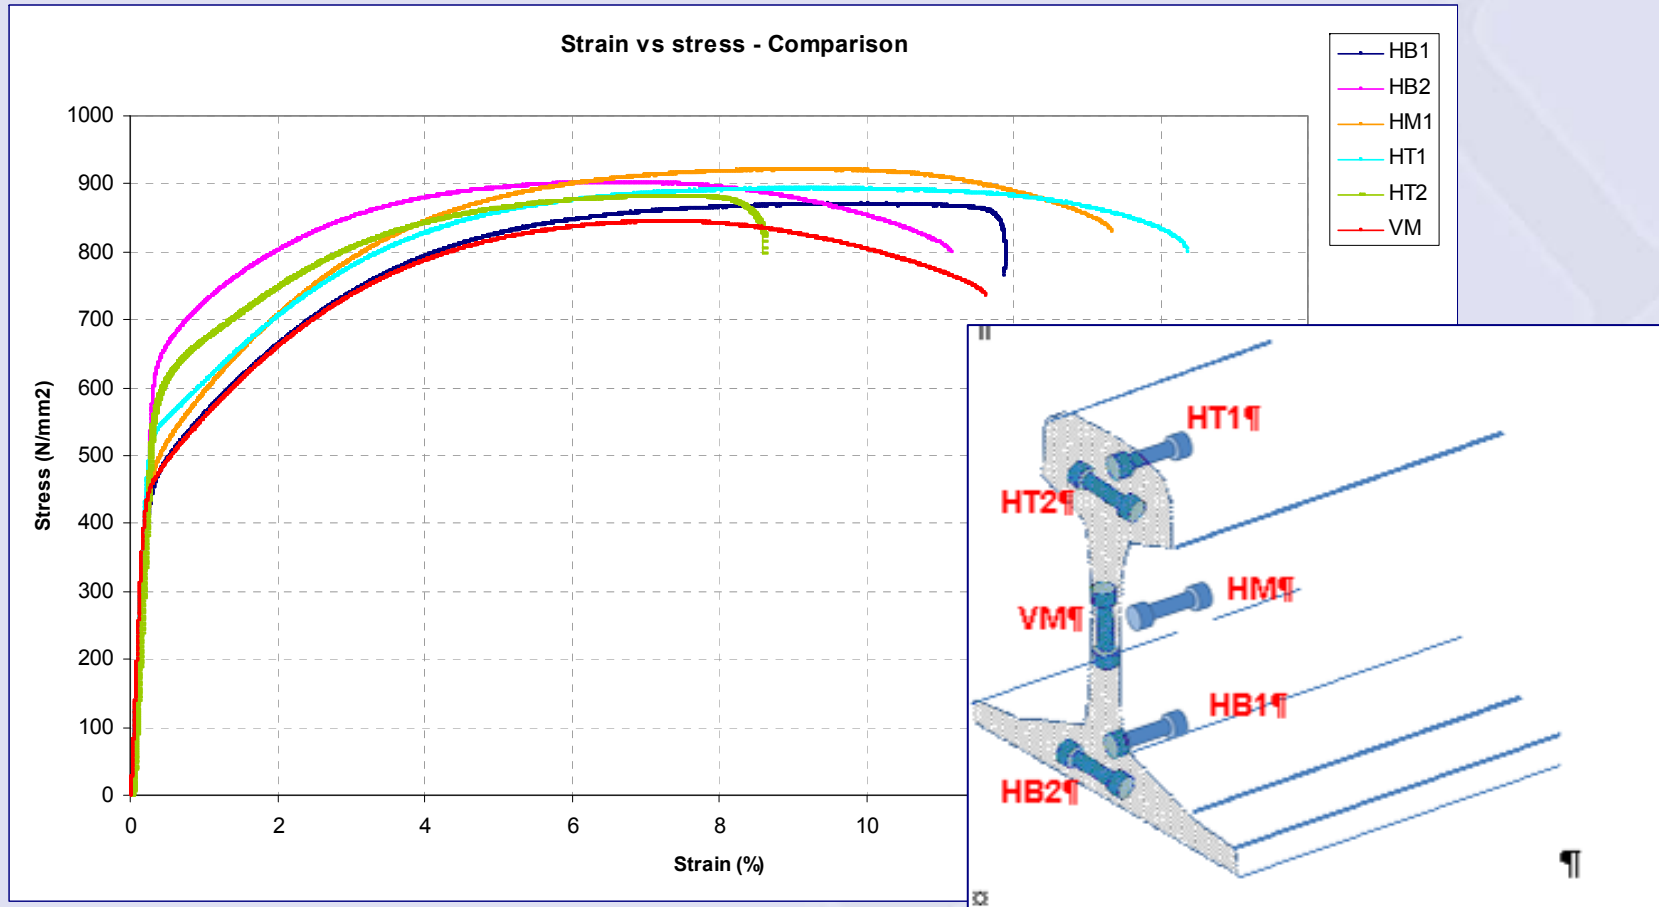
Tensile Testing

- Test results

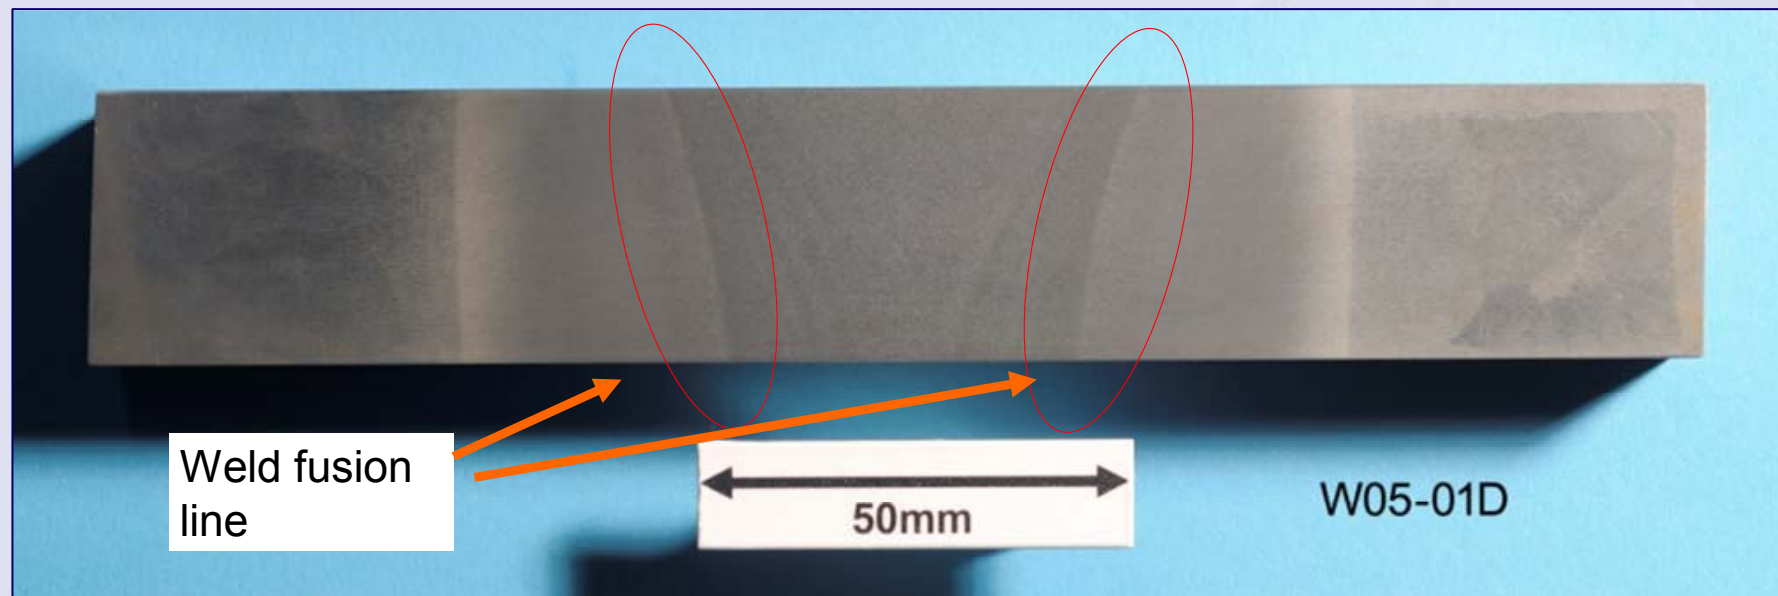
Fracture Toughness Testing

- Test results
 - All specimens failed in brittle fashion and displayed a low fracture toughness value
 - Failure mode is not a single event brittle fracture. A sequence of various cleavage propagation and arrest events seemed to occur.

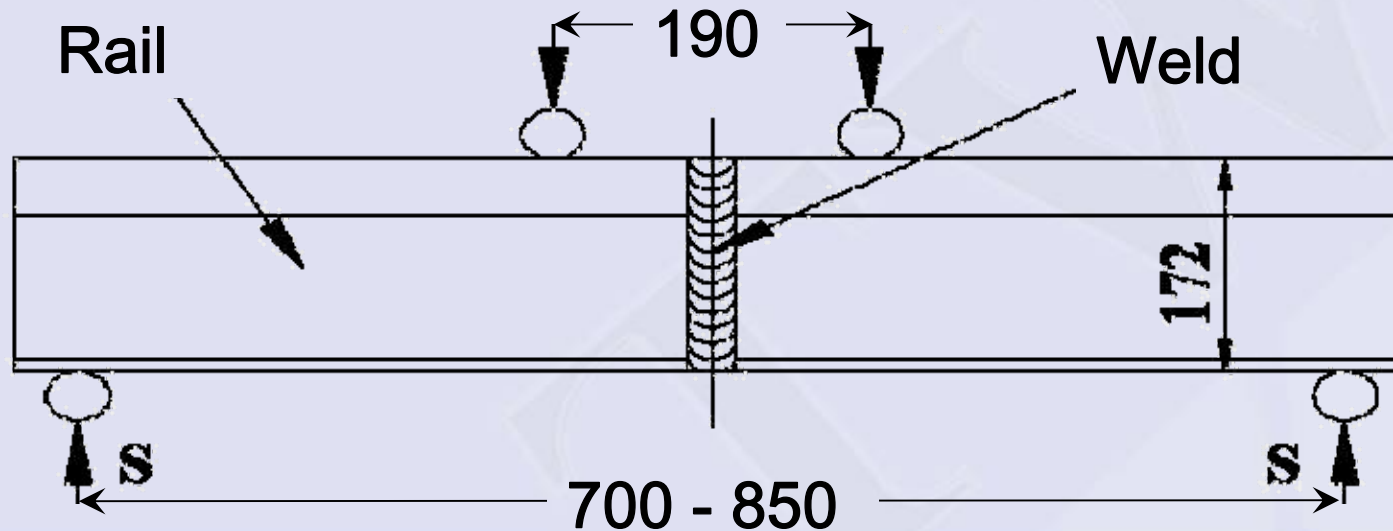
Fatigue Test Configuration

- Technique used
 - Four point bend fatigue testing (BS EN 14730-1:2006)
 - Spans
 - Upper = 190mm,
 - $700\text{mm} < \text{Lower span} < 850\text{ mm}$ depending on sample length

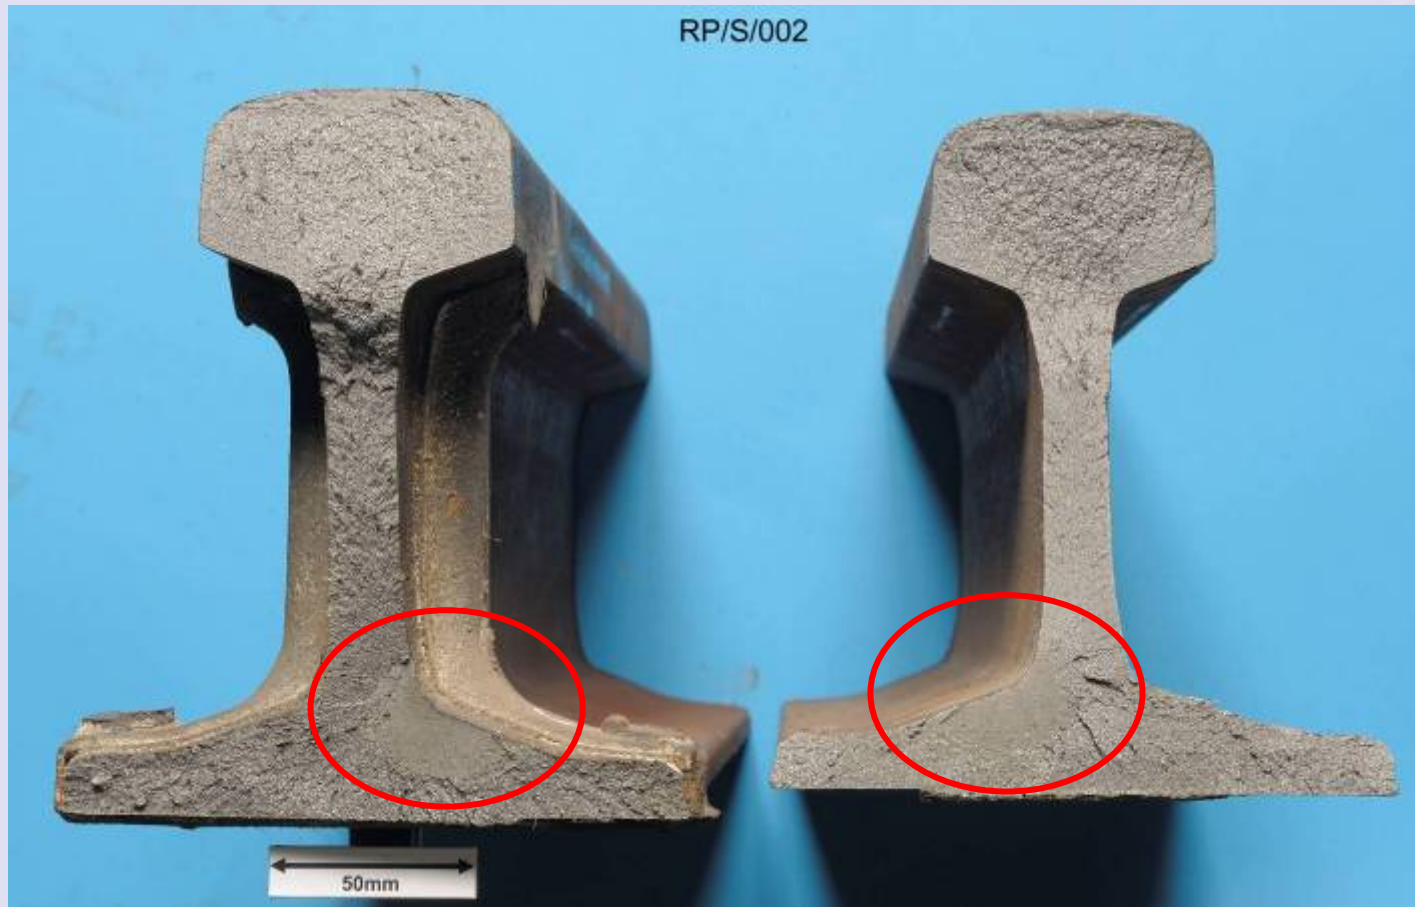
- Sample RP/S/002 (No defect)

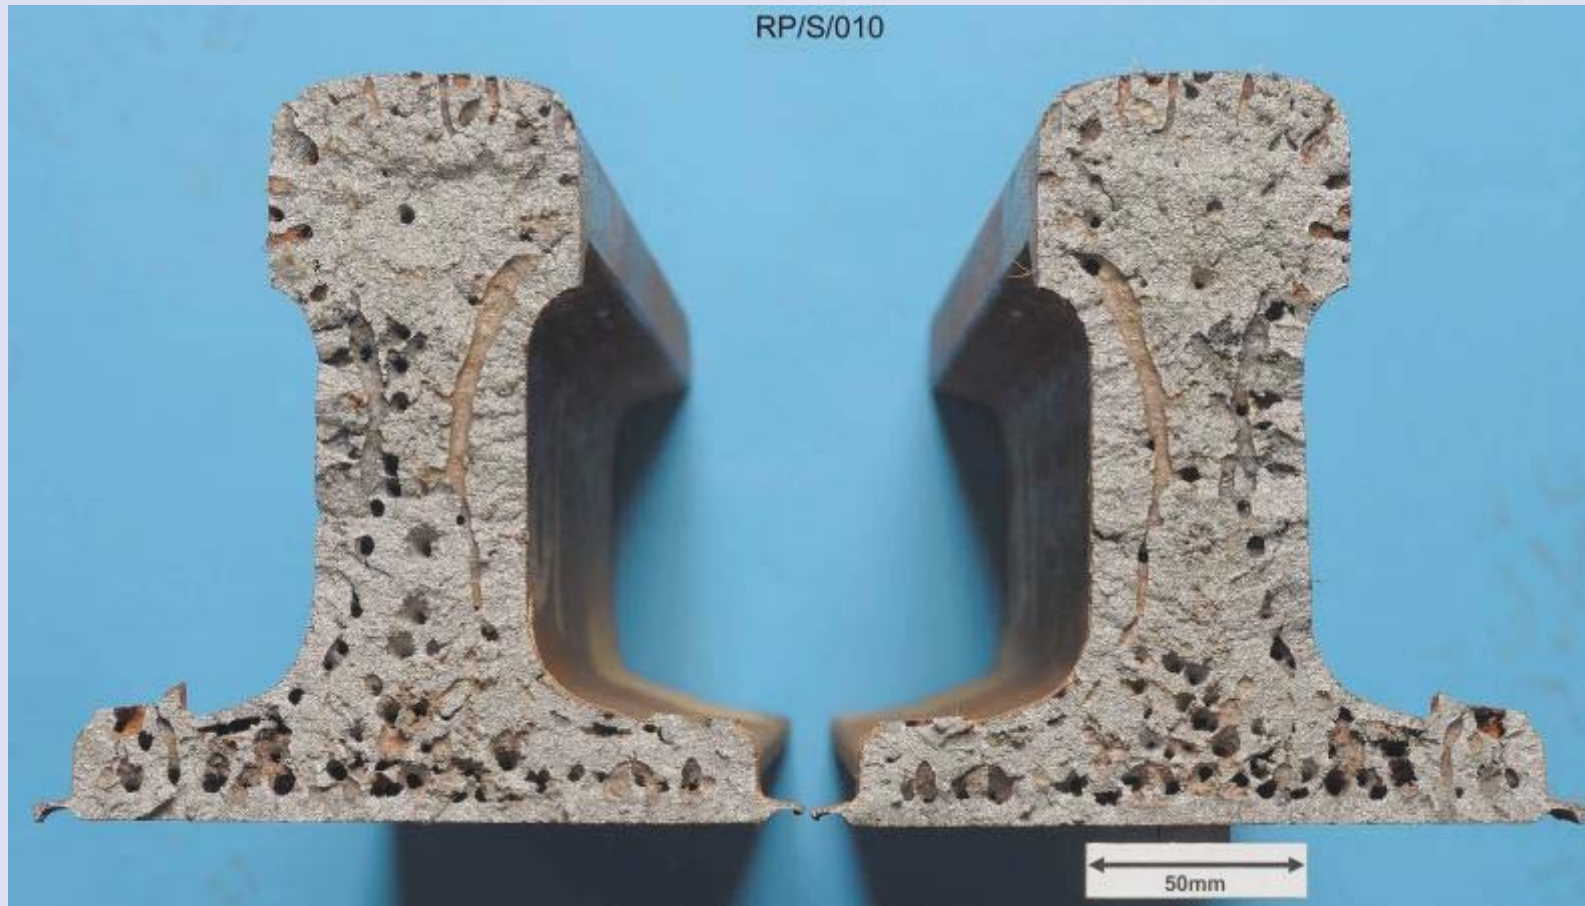
- Sample RP/S/010 (Porosity)

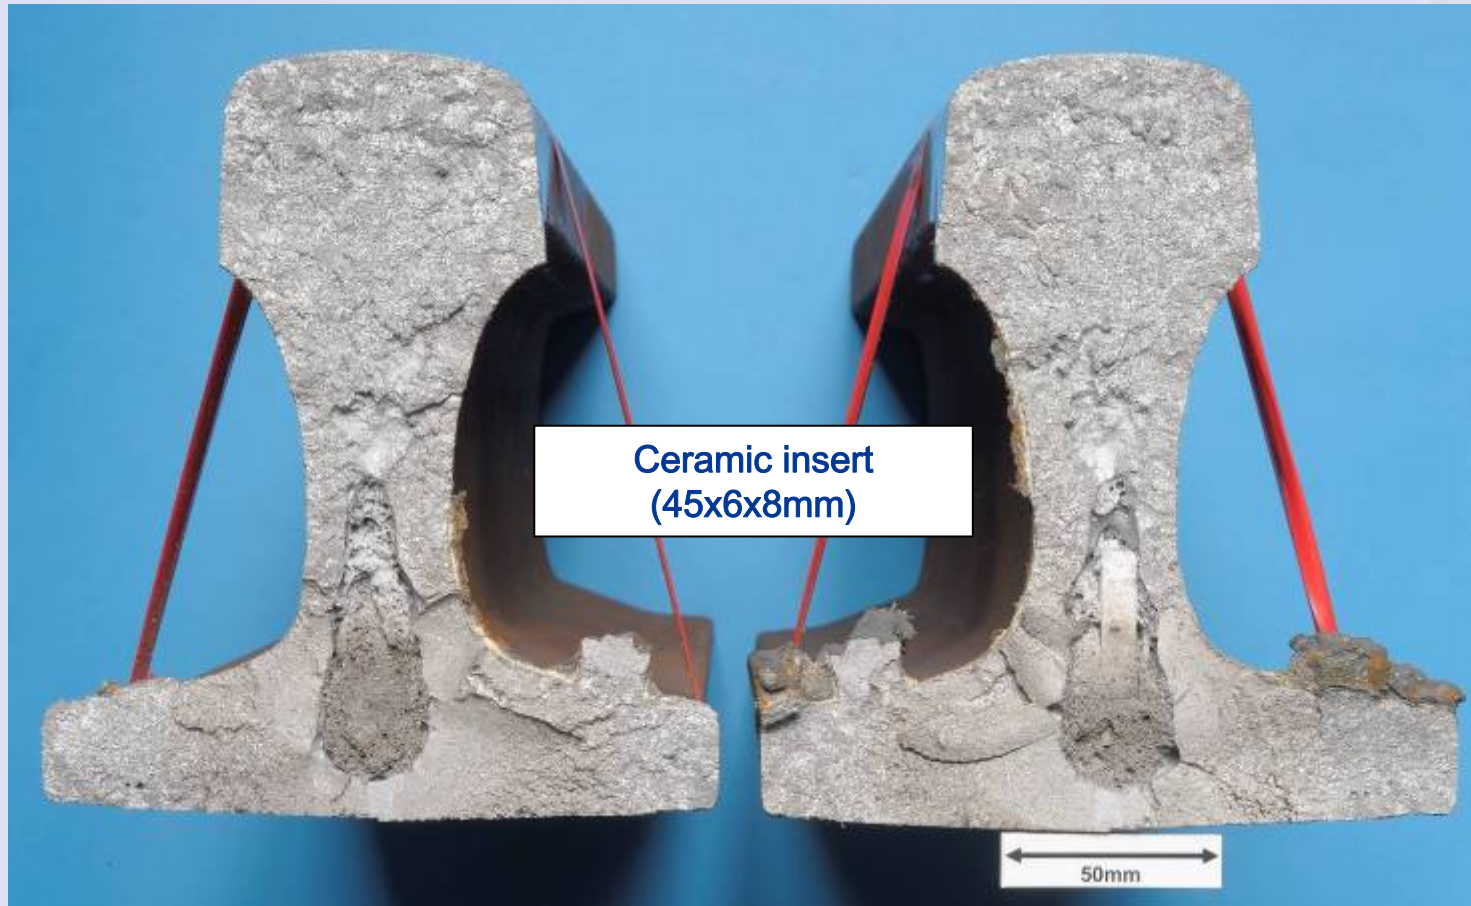
- Sample S6 (Shrinkage defect)

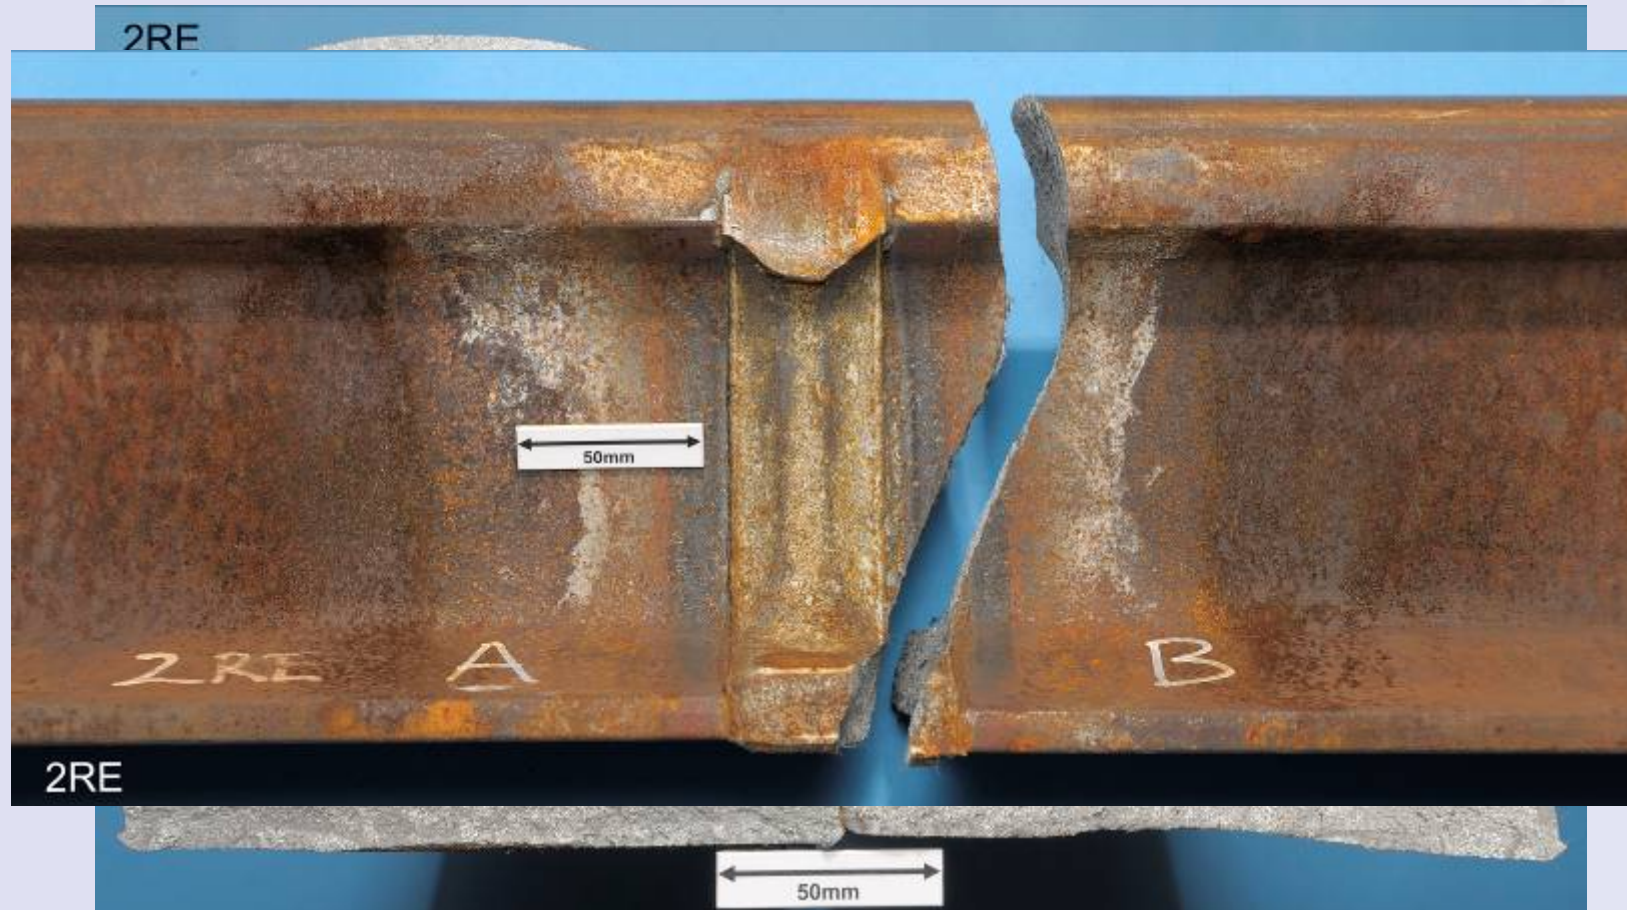
- Sample 2RE (Lack of fusion defect)

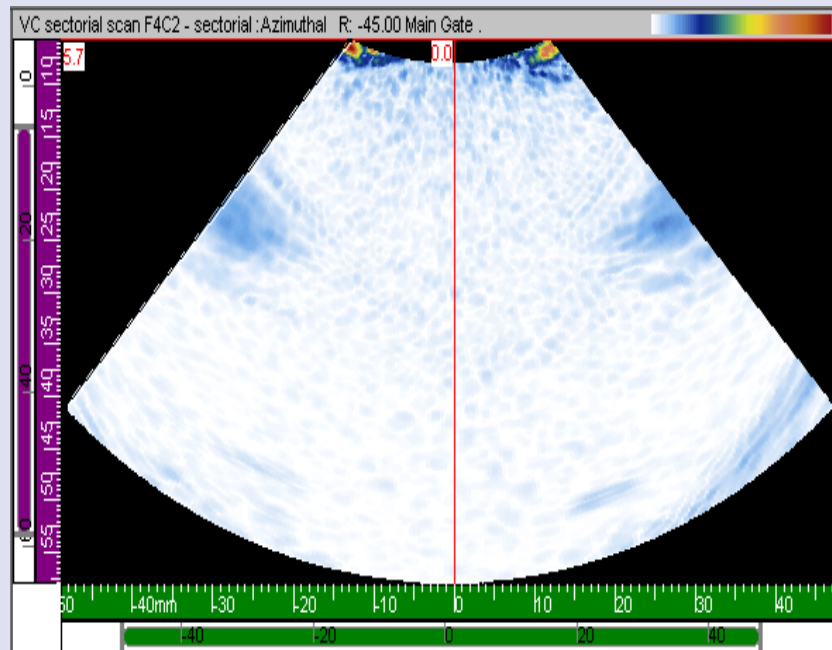
Non defective rail head

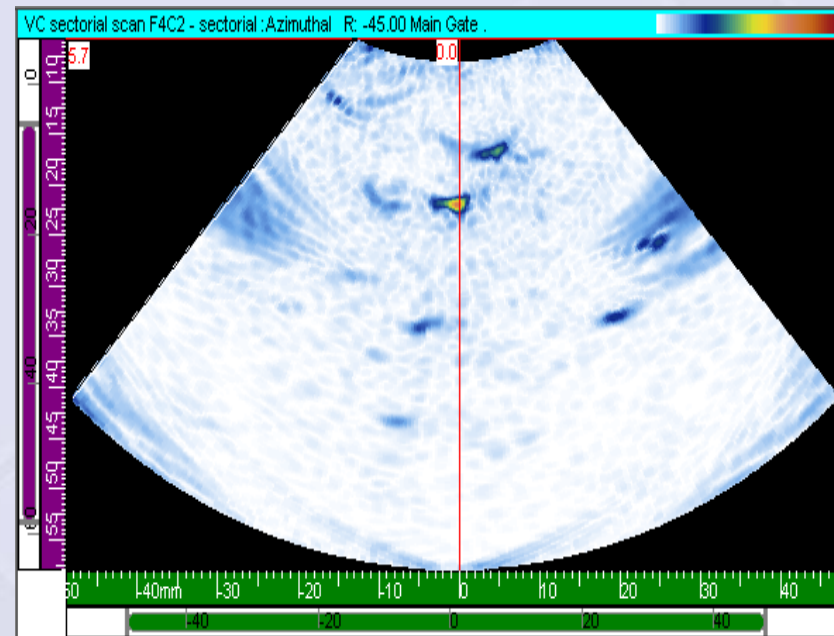
Porosity in the rail head

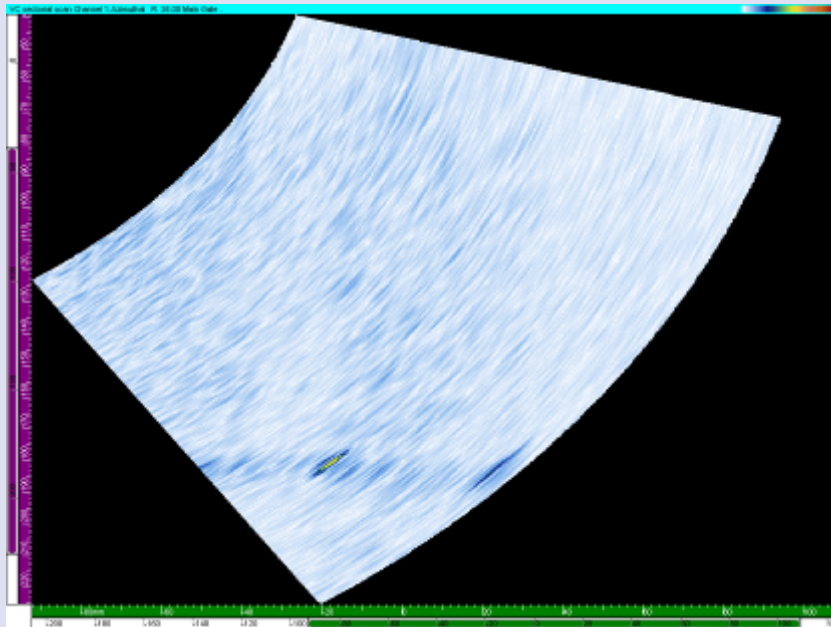
Non defective rail web

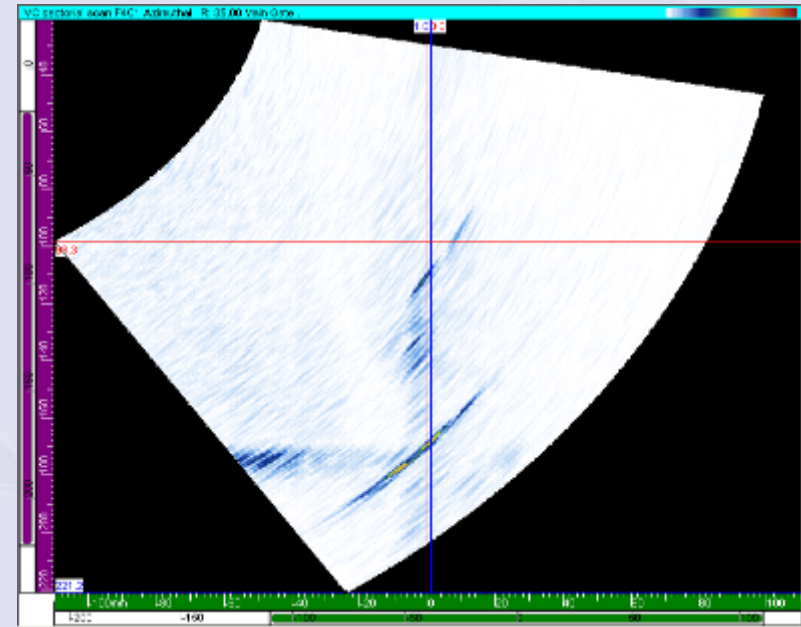
Shrinkage in the rail web

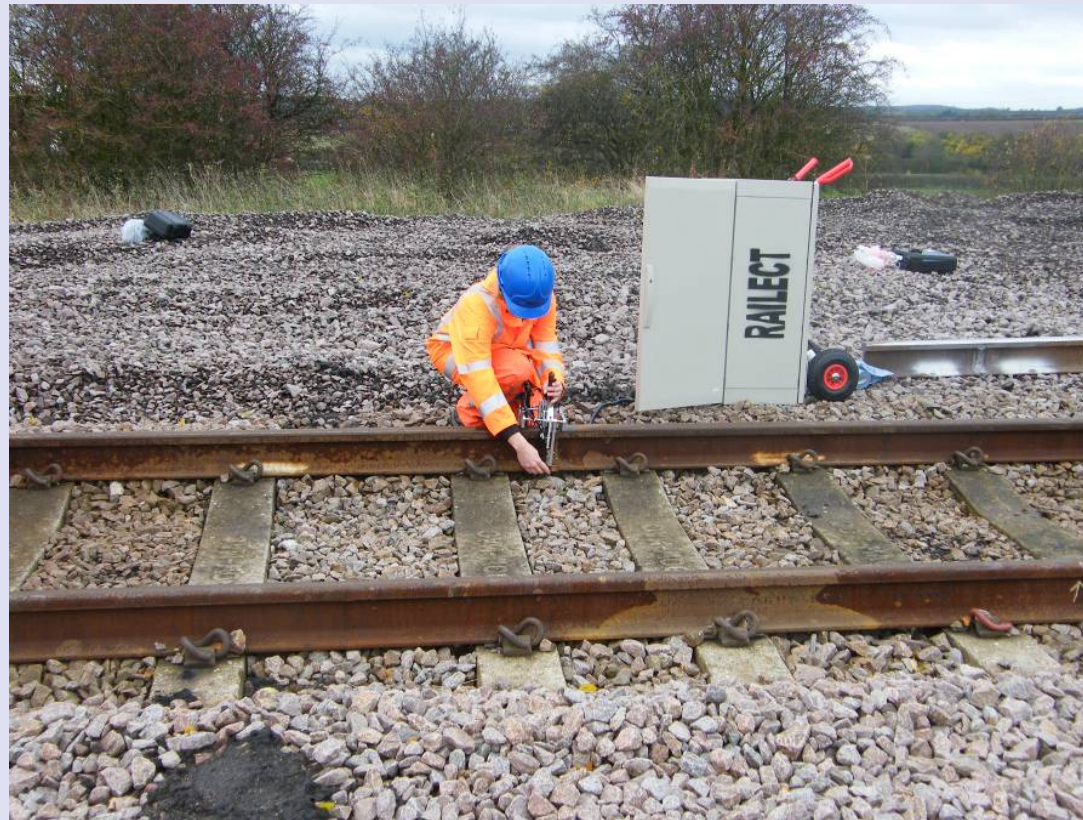
- Demonstration at Network Rail's test track, Rail Innovation and Development Centre, High Marnham, UK
